UNDERWATER BRIDGE INSPECTION REPORT

STRUCTURE NO. 23501

ROOT RIVER

DISTRICT 6 - FILLMORE COUNTY

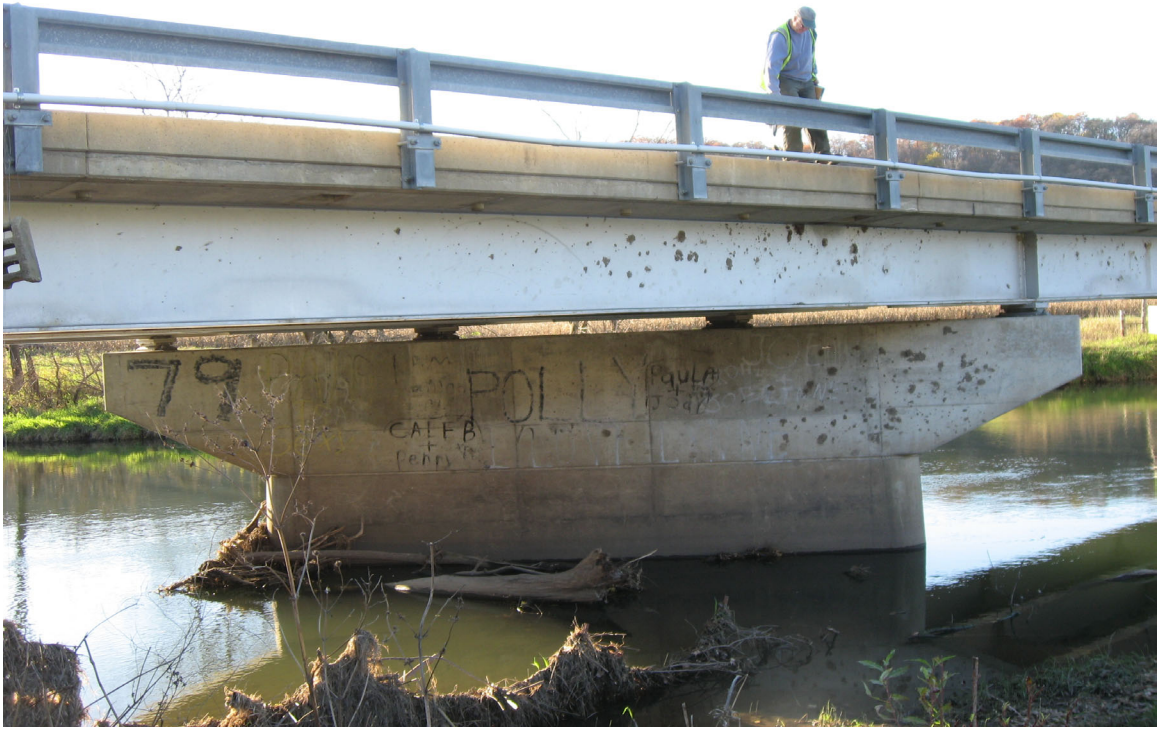
Photograph 1. View of Pier 1, Looking Southwest.

- (A) A heavy accumulation of 2 foot diameter and smaller timber debris was observed extending from the channel bottom to 2 feet above the waterline at the upstream end and along both faces of Pier 1.

- (A) Remove the heavy accumulations of timber debris around Piers 1 and 2 to alleviate adverse effects for the channel bottom and the piers.
- (B) Scour rating indicates that bridge has the potential to be at greater risk for scour with further scour analysis required. Giving the undermining, consideration may need to be given for riprap to be properly designed and placed around the piers and in the scour/undermining areas to armor against further scour, unless further scour analysis indicates differently.
- (C) Reinspect the submerged substructure units at the normal maximum recommended (NBIS) interval of five (5) years.

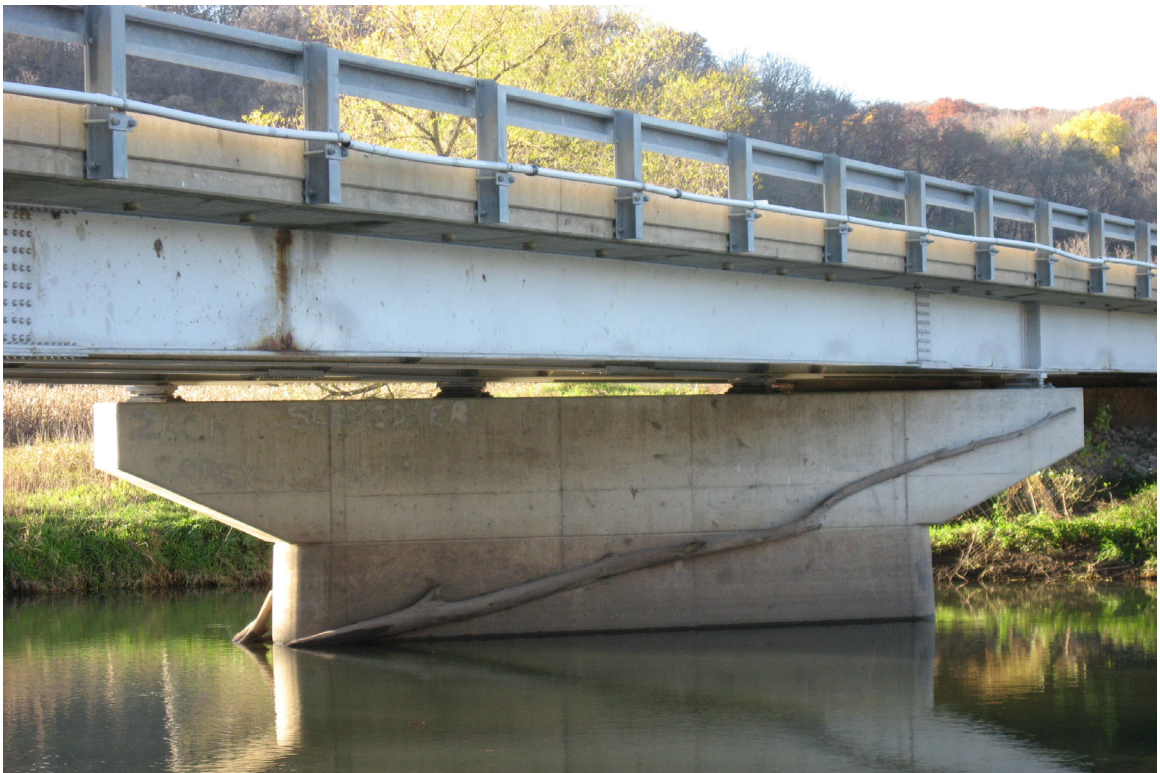
Photograph 2. View of Pier 2, Looking Southwest.

- (B) A tree trunk, 1.5 feet in diameter (forked around pier), and some smaller timber debris was observed extending from the channel bottom to the top of the pier cap at the upstream end of Pier 2.

- (C) The footing was exposed all around Pier 2 with undermining and exposed steel H-piles observed from the midpoint along the east face, around the upstream southeast corner, and extending to the midpoint of the upstream end with a maximum height of 1 foot and 4.5 feet of horizontal penetration. The exposed steel H-piles were all sound with no notable deterioration.

- (D) Two vertical hairline cracks were observed at the midpoint of Pier 2 that extended from the top of the pier cap to 2 feet below the waterline on the east face and to the channel bottom on the west face.

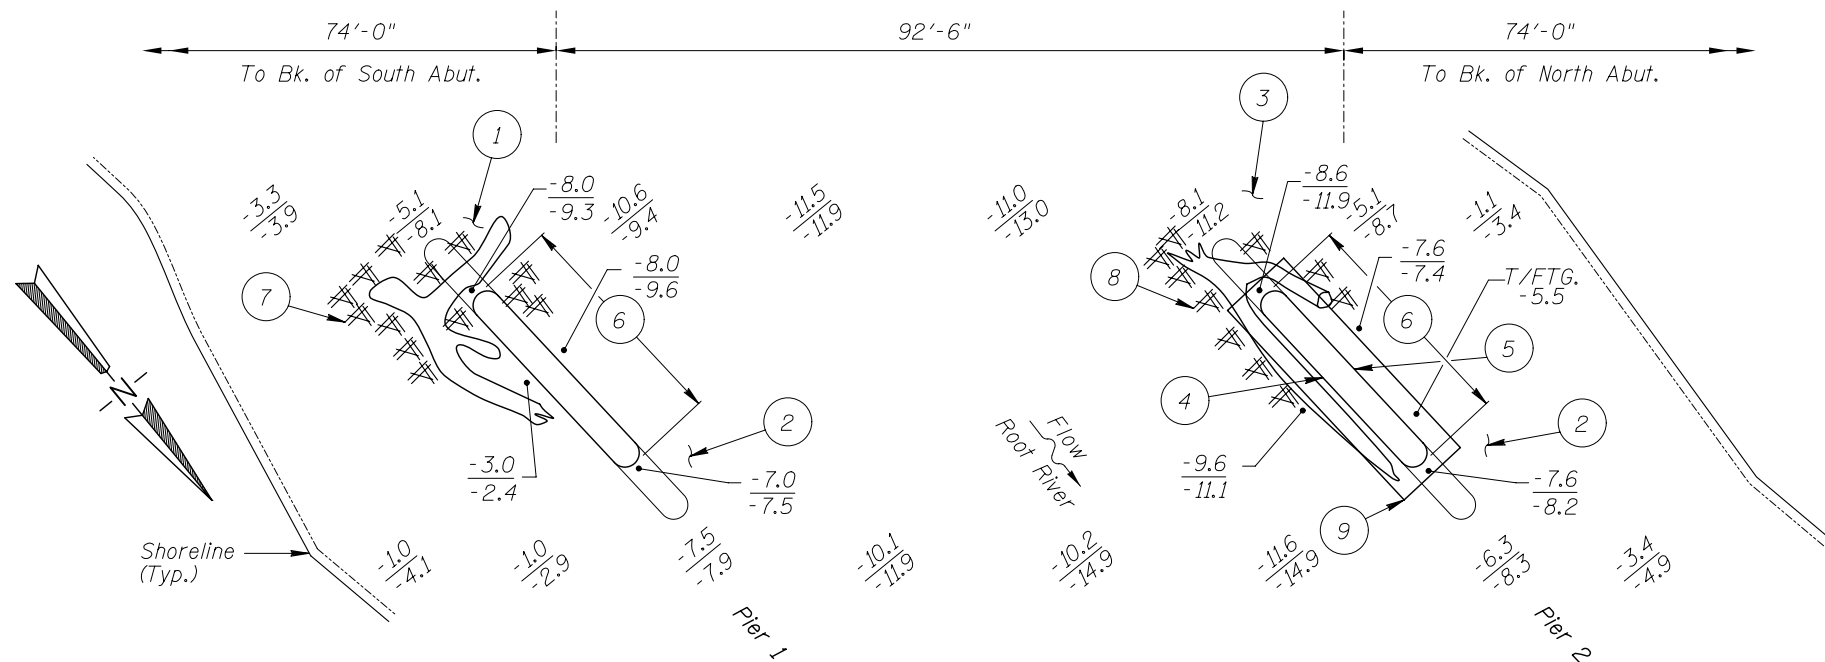
SOUNDING PLAN

- 1 The channel bottom consisted of gravel and silt with up to 2 inches of probe rod penetration.
- 2 The channel bottom consisted of silty sand with up to 1 foot of probe rod penetration.

- 3 The channel bottom consisted of soft silt with up to 1.5 feet of probe rod penetration.
- 4 A vertical hairline crack was observed at the midpoint of Pier 2 that extended from the top of the pier cap to 2 feet below the waterline.

- 5 A vertical hairline crack was observed at the midpoint of Pier 2 that extended from the top of the pier cap to the top of the footing.
- 6 Light scaling was observed along all pier faces from 1 foot above to 1 foot below the waterline with a maximum penetration of 1/16 inch.

- 7 A heavy accumulation of 2-foot-diameter-and-smaller timber debris was observed extending from the channel bottom to 2 feet above the waterline at the upstream end and along both faces of Pier 1.

- 8 A 1.5-foot-diameter tree trunk and smaller timber debris was observed extending from the channel bottom to the top of the pier cap at the upstream end of Pier 2.

- 9 The footing was exposed at Pier 2 with undermining and steel H-piles observed from the midpoint along the east face, around the upstream southeast corner, and extending to the midpoint of the upstream end with a maximum height of 1 foot all along the undermined area, and 4 to 5 feet of horizontal penetration. The exposed steel H-piles were sound without any notable deterioration.

Remove the heavy accumulations of timber debris around Piers 1 and 2 to alleviate adverse effects for the channel bottom and the piers.

Scour rating indicates that bridge has the potential to be at greater risk for scour with further scour analysis required. Giving the undermining, consideration may need to be given for riprap to be properly designed and placed around the piers and in the scour/undermining areas to armor against further scour, unless further scour analysis indicates differently.
